# Digital navigation: old skills in new technology

Lessons from the grounding of the Nova Cura

*The Hague, September 2017*

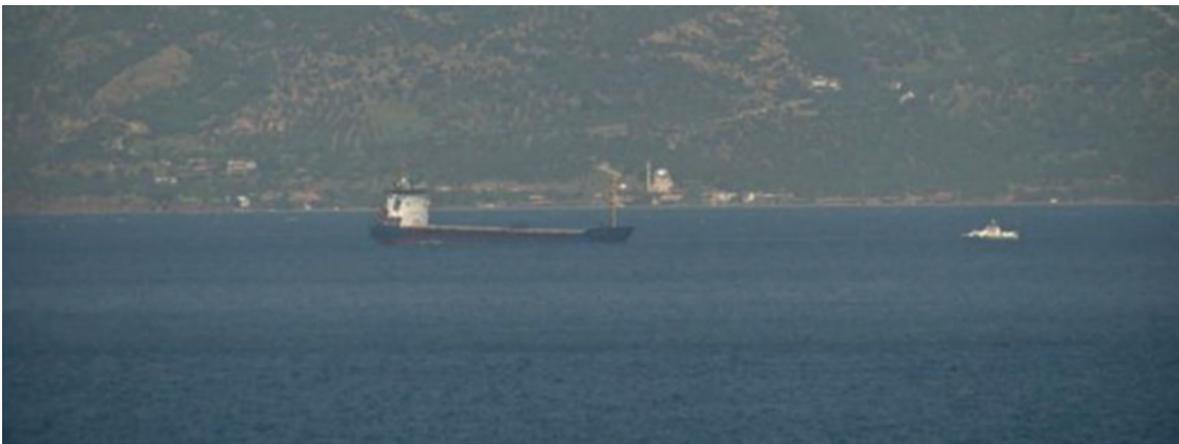
Figure 1: The Nova Cura grounded in Mytilini Strait (Greece). Source: Dutch Safety Board

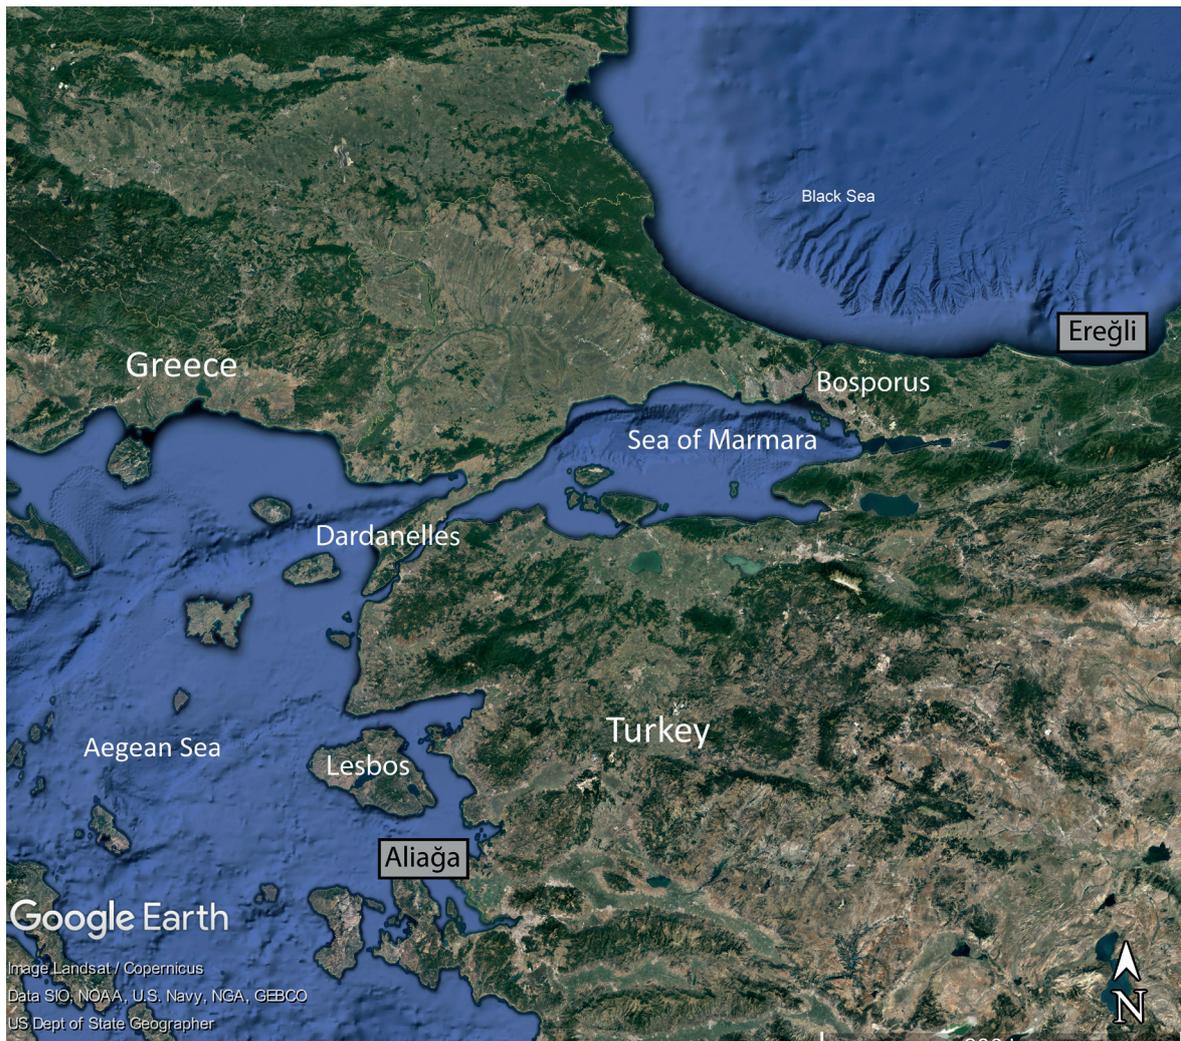
Figure 2: Overview of the planned route. Source: Google Earth

Ereğli is at the Black Sea. To go to Aliaga the Nova Cura had to pass the Bosphorus to the Sea of Marmara and afterwards via the Dardanelles to the Aegean Sea (see figure 2). The passage planning had been done by the second mate before departure. A so-called Electronic Chart Display and Information System (ECDIS, see blue box) was being used on the Nova Cura for navigation.

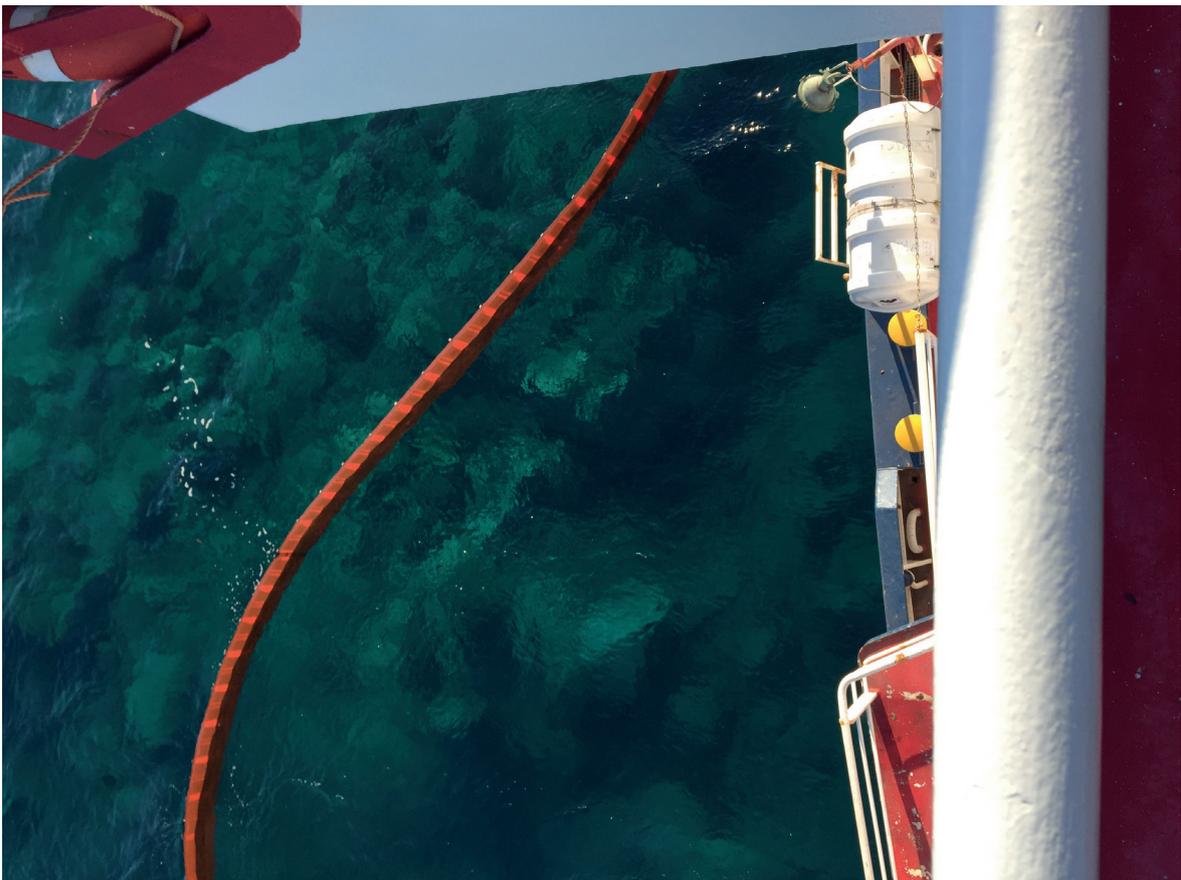
*Figure 4: The rocks were visible from the bridge wing of the Nova Cura. Source: Crew Nova Cura*

At 09:55 hours a heavy vibration went through and the Nova Cura came to a full stop. The ECDIS screen indicated a water depth of 112 metres at that position. The captain immediately moved the telegraph into the neutral position, setting the thruster's pitch to zero. This eliminated the thrust generated by the thruster. It quickly became clear that the vessel had to have run aground. This was confirmed when the captain looked into the water from the bridge wing. The rocks were visible through the clear water from the bridge wing, see Figure 3.

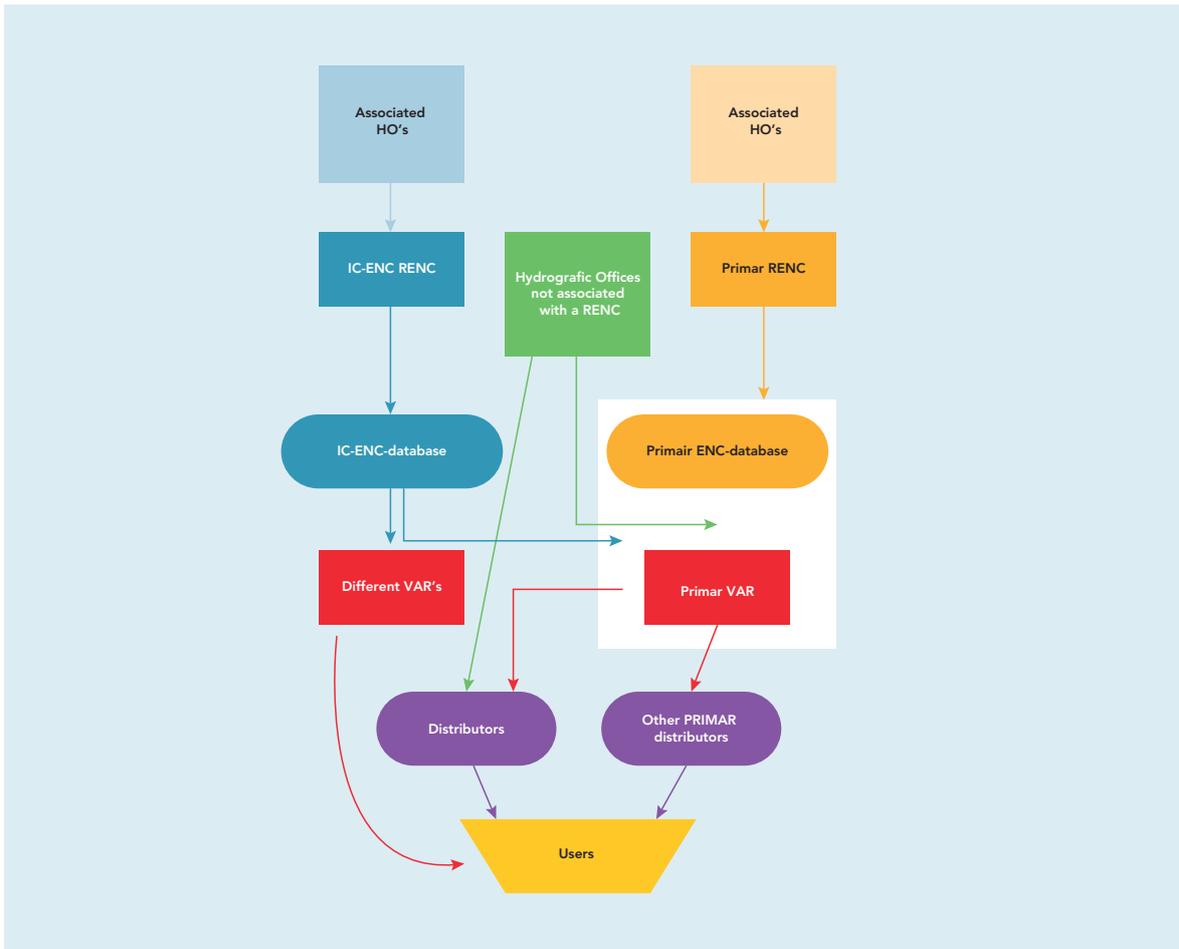
Figure 5: The process of developing digital nautical charts with the actors involved. <sup>8</sup>

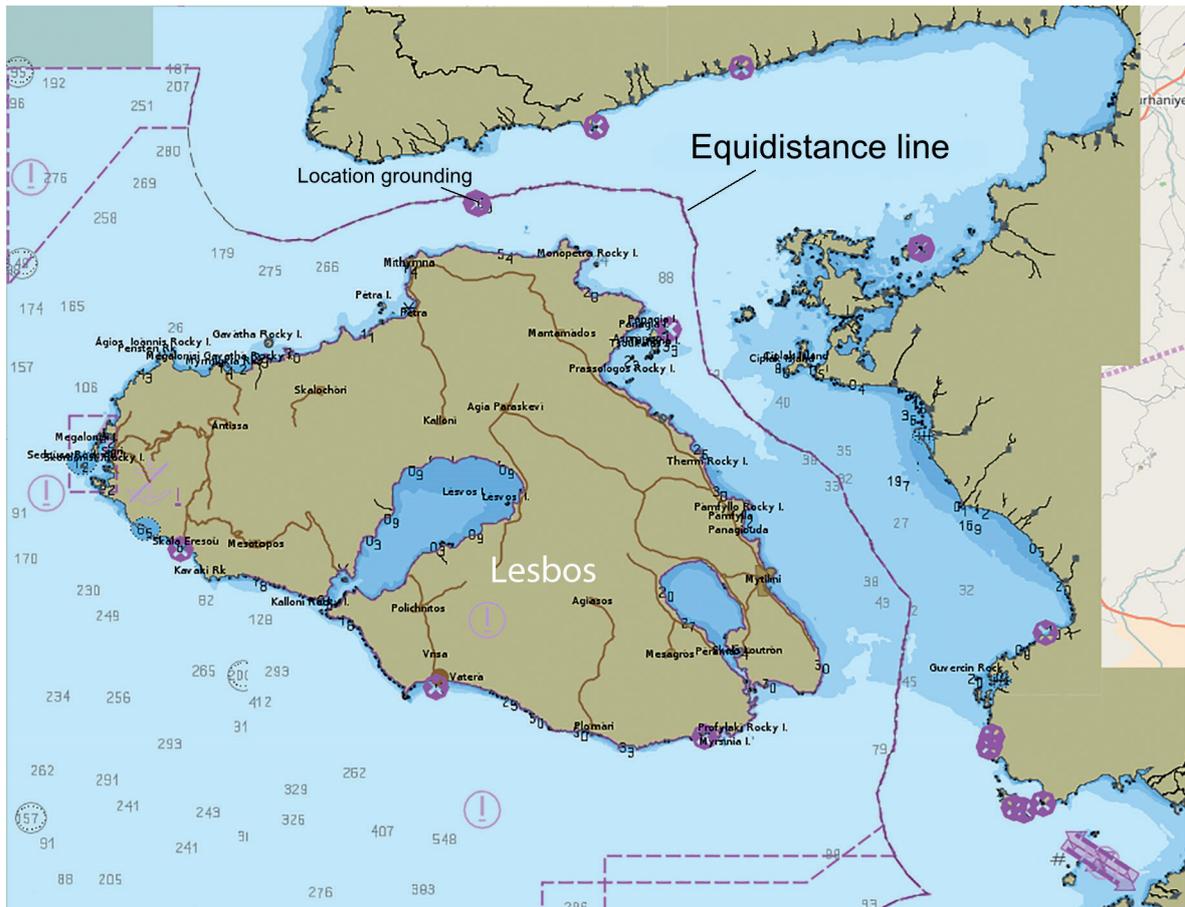
Figure 6: Border between Greece and Turkey in Mytilini Strait. Source: GR4APP01

Lamnas Reef is a shallow area located in Mytilini Strait. Mytilini Strait is a waterway that forms the border between Turkey and Greece (near the Greek island of Lesbos), see Figure 6. Lamnas Reef is located partly in Greek waters and partly in Turkish waters.

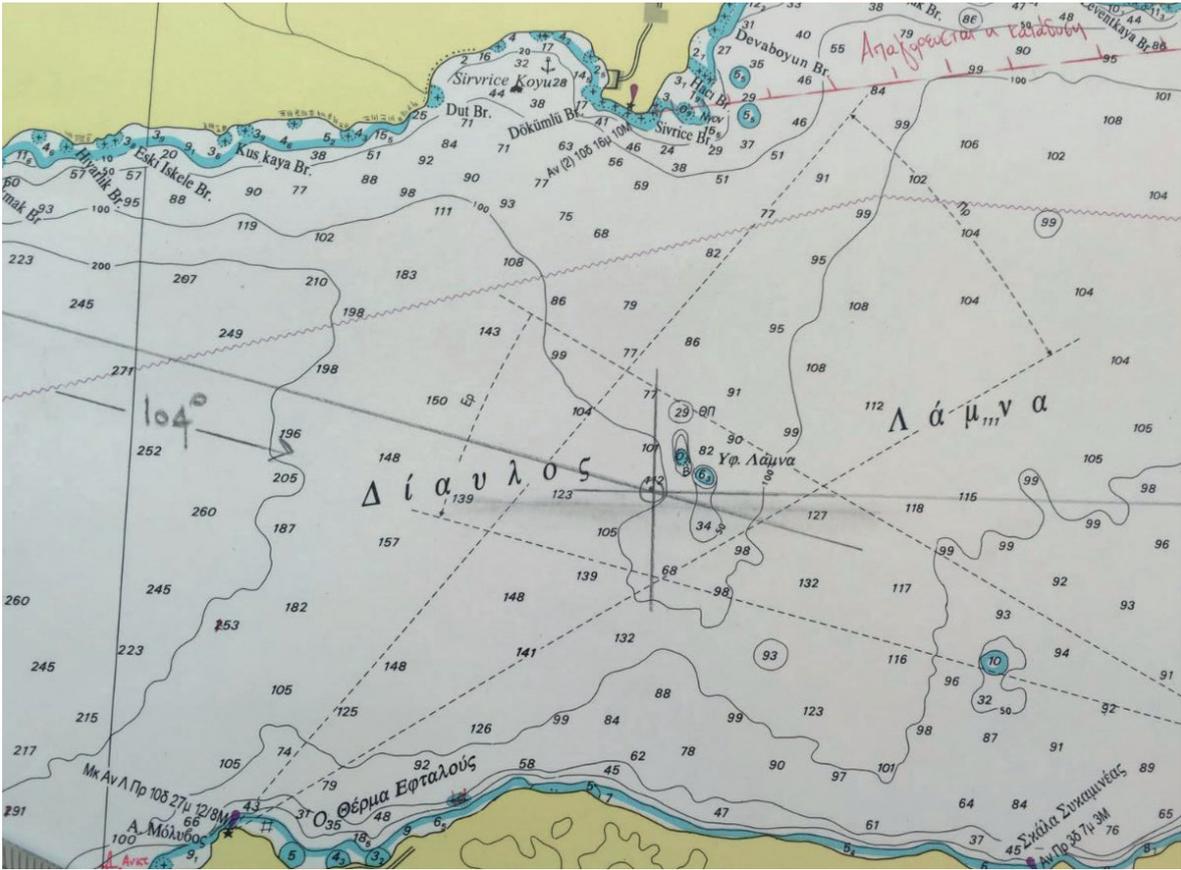
Figure 7: Greek paper nautical chart of the accident site. Source: Crew Nova Cura

The HNHS has published a paper nautical chart and an ENC for Mytilini Strait, see Figure 7. The survey of the area was performed in 1967 with the equipment available at that time (analogue). Due to the emerging use of ECDIS and the demand for ENCs, the HNHS produced the first ENC of the area in 2004, based on 1967 data.

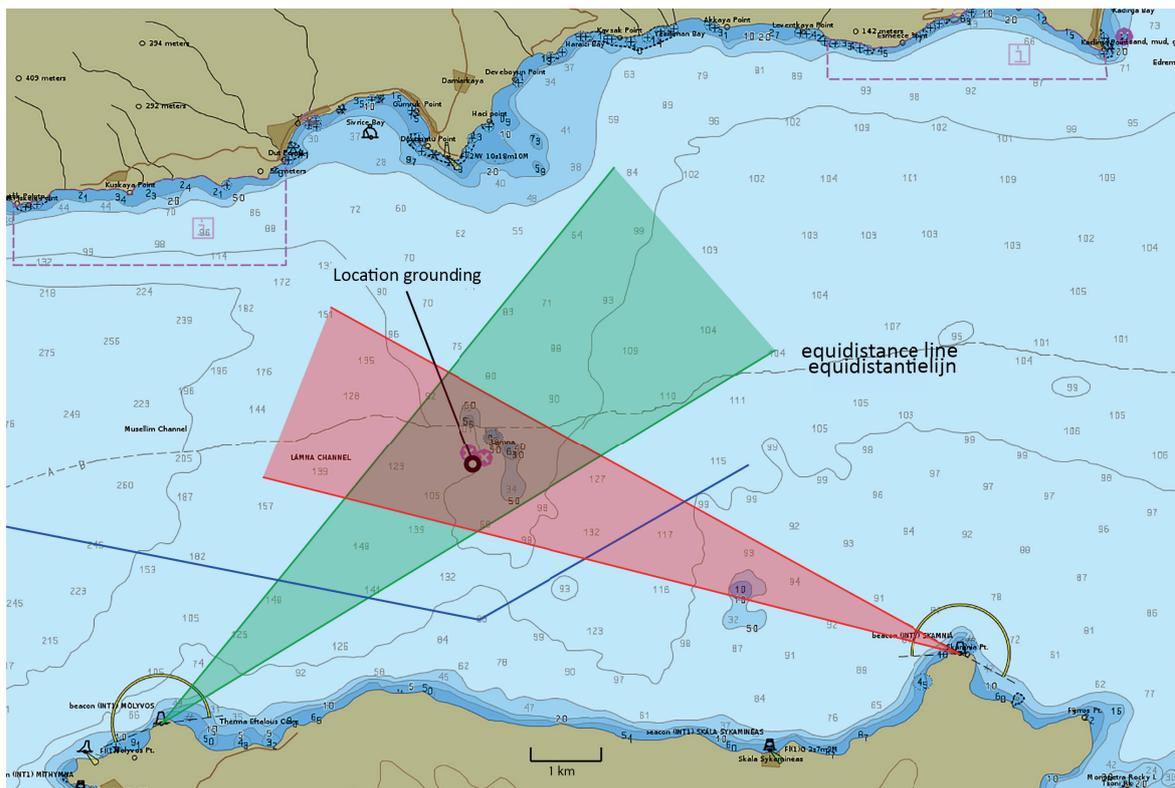
Figure 8: Sector lights in Mytilini Strait. Source: GR4APP01

The sector lights Ák Mólivos (on the left in Figure 8) and Ák Skamniá (on the right in Figure 8) are both intended to warn of the danger of Lamnas Reef. In this case, the danger is located in the area illuminated simultaneously by both the green and the red sector lights. For the passage south of Lamnas Reef, coming from the west as the Nova Cura had intended (on the left of Figure 8), the vessel should approach in the left white sector of Ák Skamniá (see blue line<sup>9</sup> in Figure 8). Only when the vessel has passed the green sector of Ak Mólivos, can it go to the port side; in this case both sector lights are white. After that the vessel passes the red sector of Ak Skamniá and has passed Lamnas Reef. The coordinates of the area covered by the sector lights were also stated in the Pilots for the area (NP48). It is not forbidden to sail in the green or red sector of sectorlights.

Lamnas Reef was charted with analogue equipment in 1967. The danger associated with Lamnas Reef had been identified by the HNHS at that time. To assist mariners with the passage through Mytilini Strait two sector lights are installed on the Greek island of Lesbos, both of which indicate the danger near Lamnas Reef, see Figure 8.

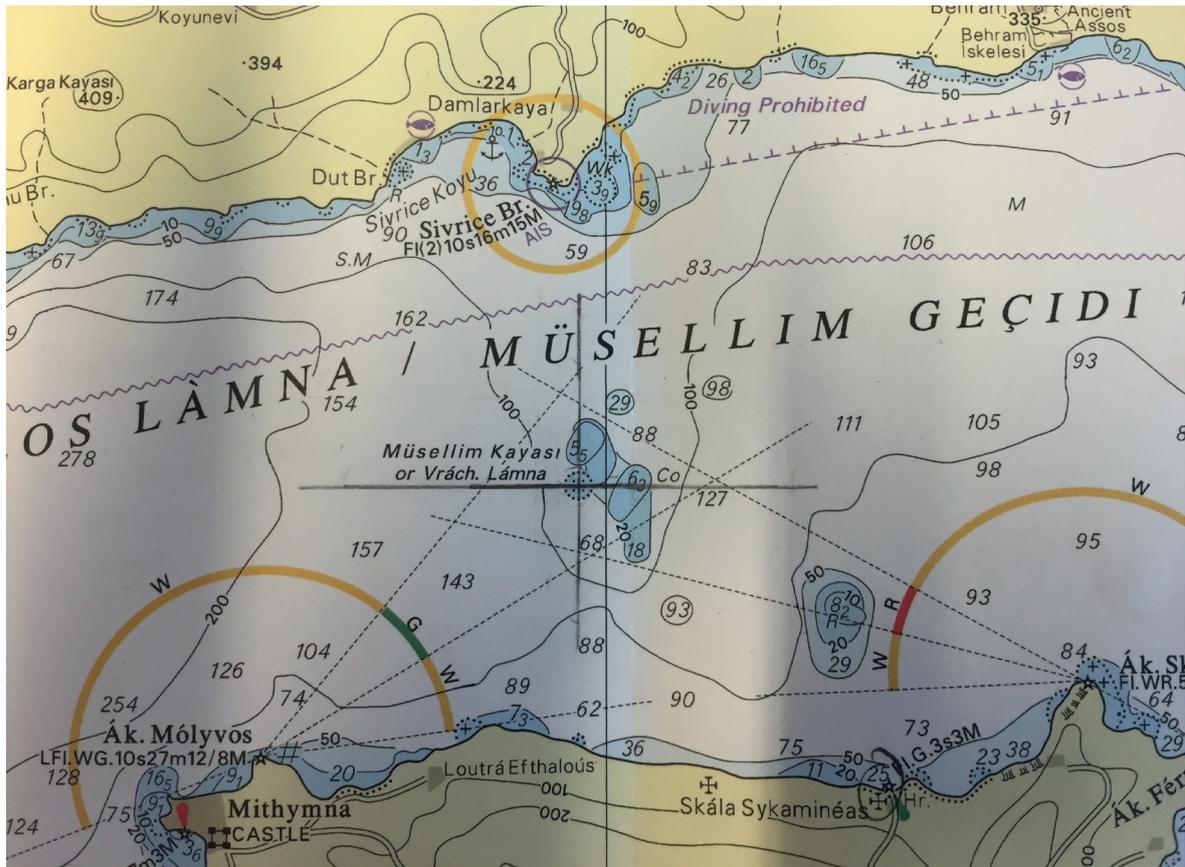
Figure 9: Lamnas Reef in BA1061.

The UKHO publishes paper nautical charts in the British Admiralty Series through Admiralty Maritime Products & Services. The UKHO copied the Greek paper nautical chart supplemented with the information known to them and published it under number 1061. The chart number is BA1061. The UKHO has satellite images of Mytilini Strait, among other things, and incorporated this information in BA1061, see Figure 9.

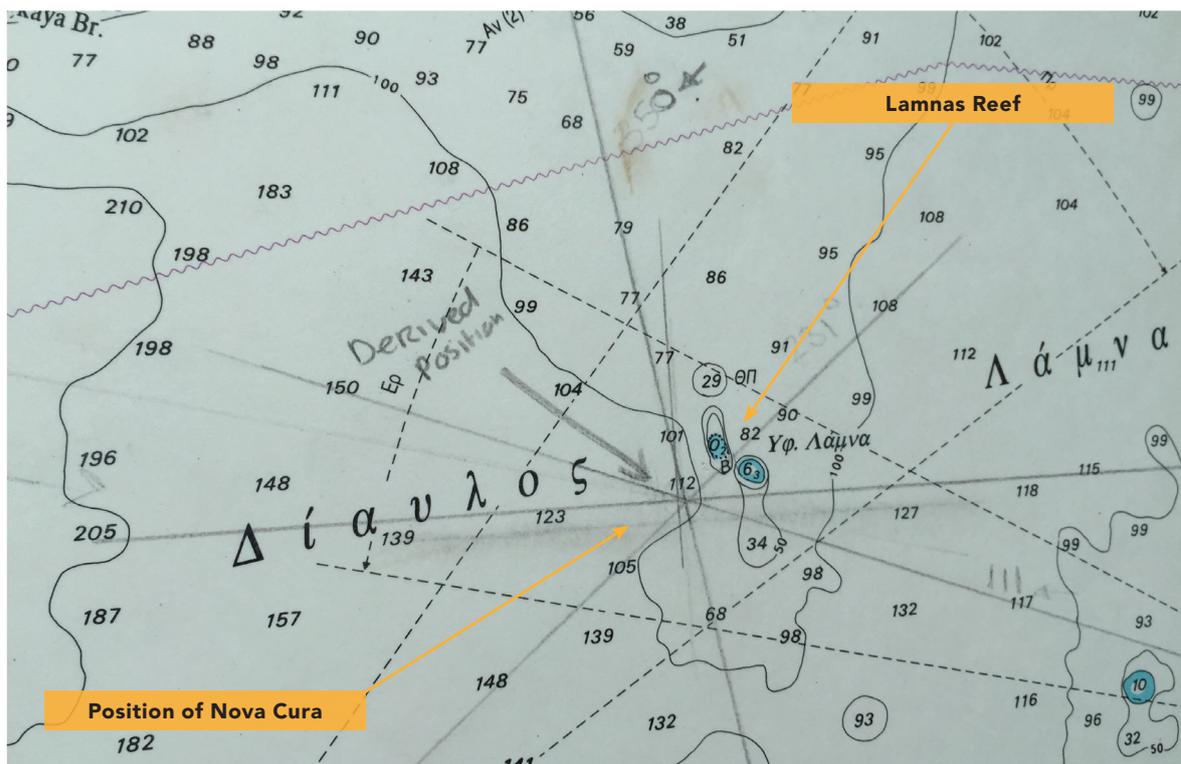
Figure 10 shows the position of the Nova Cura in relation to Lamnas Reef. The GPS position of the Nova Cura was verified by taking cross bearings. The position where the Nova Cura ran aground is 0.2 miles more south than the charted shallow area.

Figure 10: Result of cross bearings showing the position of the Nova Cura on the Greek paper nautical chart.

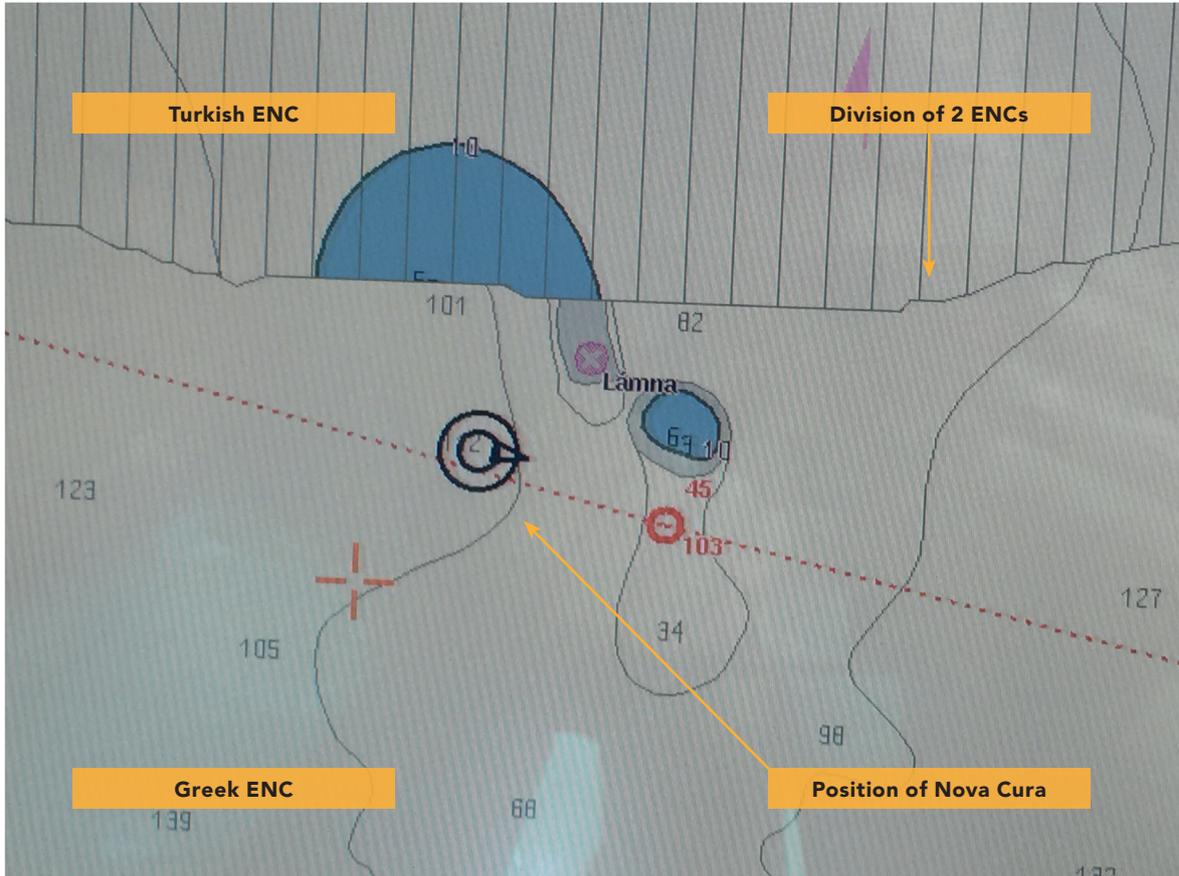
ECDIS was used on board the Nova Cura for navigation and not paper nautical charts. Figure 11 shows the position of the Nova Cura on ECDIS; it shows the same image as the Greek paper nautical chart. Figures 10 and 11 both show that the depth of the water at the location where the Nova Cura ran aground should be 112 metres, according to the Greek nautical charts.

Another striking point in Figure 11 is the division between two ENC's. The scale of the bottom ENC differs from that of the top ENC (illustrated by the vertical lines) and the shallow water in the top ENC (blue area) ends abruptly on the division between the ENC's. The division between the two ENC's corresponds to the location of the border<sup>12</sup> between Turkey (top section) and Greece (bottom section).

Figure 11: ECDIS image of the accident site. Source: ECDIS Nova Cura

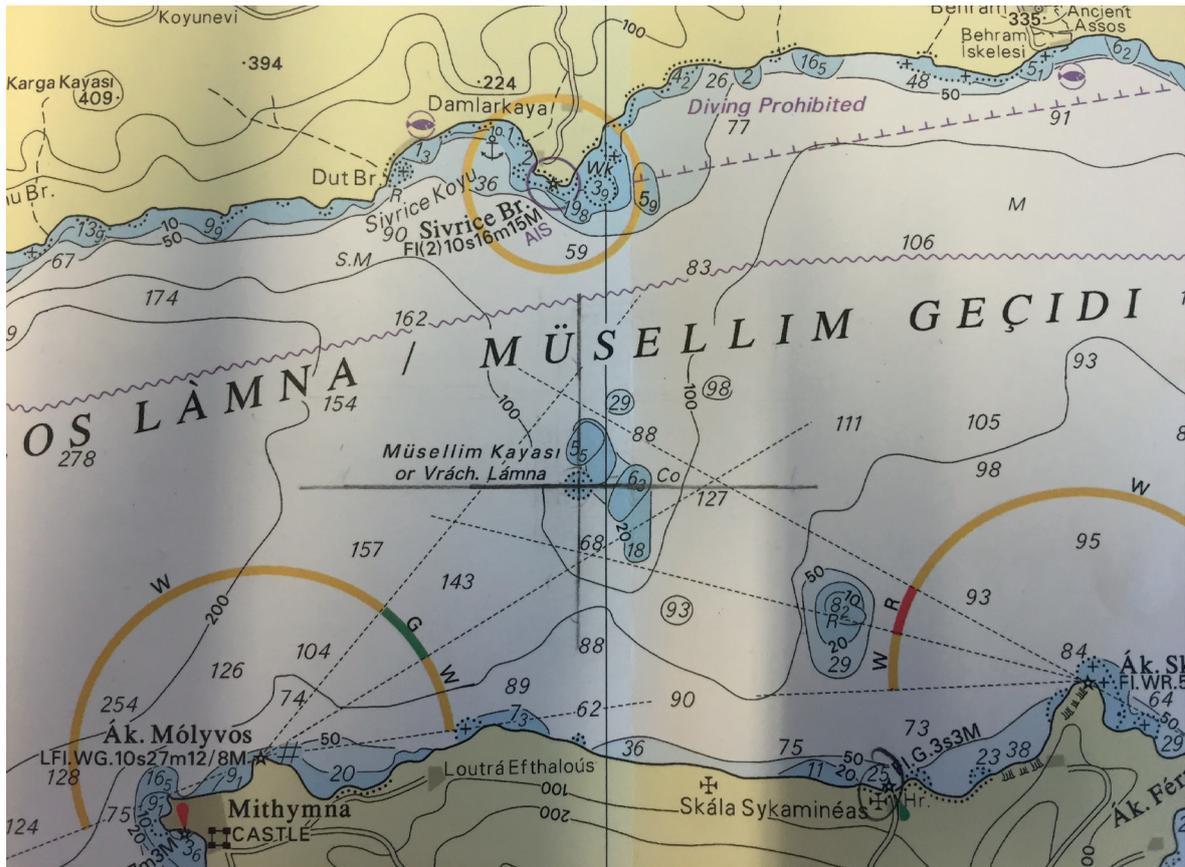
Figure 12: The accident site plotted on BA1061.

As stated earlier in this report, only countries whose waters are involved, may create and publish ENC's. Or let other hydrographic offices do this on their behalf. This is in contrast to paper nautical charts. The UKHO's chart, BA 1061, incorporates information from various countries and information sources. Figure 12 shows that BA1061 therefore provides a more complete picture of the accident site. It shows that the shallow water where the Nova Cura ran aground was actually visible.

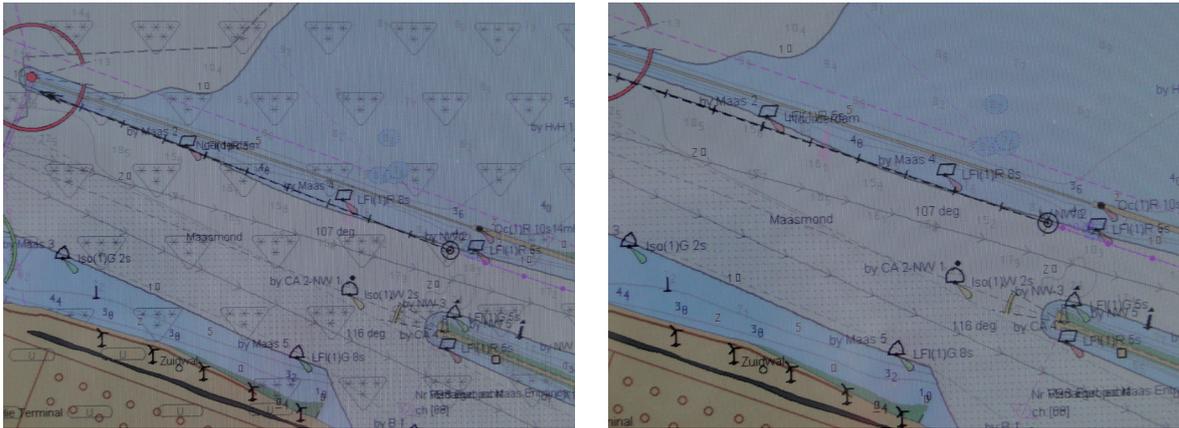
Apart from being unaware of the CATZOC, the setting in ECDIS is not very user friendly. The layer which makes the CATZOC visible in ECDIS can be 'enabled' or 'disabled'. If this layer is constantly 'enabled', the image becomes contaminated, as shown in Figure 13. Therefore it is good practice to 'enable' the layer for a while during voyage preparations to verify the different CATZOCs located on the route. It is equally important to check the CATZOC of the new route in the event of deviating from the planned route, particularly if it is the first voyage on that route.

Figure 13: ENC displayed, left with CATZOC 'enabled', right with CATZOC 'disabled'.

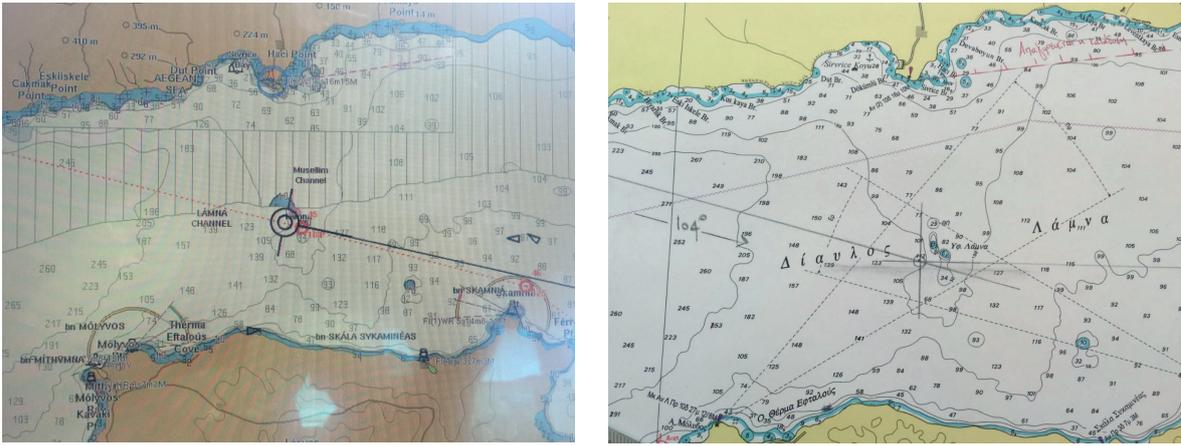
Whereas sector boundaries are drawn on a paper chart, in ECDIS the sector boundaries layer (lights) must be 'enabled' or 'disabled'. The ECDIS image and the paper nautical chart are shown next to one another in Figure 14 to clearly show the difference in the view shown. For sector boundaries in ECDIS, again everything must be 'enabled' or 'disabled. If this layer is constantly 'enabled', the image will become contaminated and will be detrimental to navigation. For this reason, it is important to highlight the relevant sector lights during voyage preparations and to 'enable' the layer temporarily, where necessary, during navigation.

Nevertheless it is striking that the sector boundaries do not extend to the danger they are covering. This in contrary to the sector boundaries on paper charts. This is why the sector lights on paper charts work more intuitive than on the ENC's.

Figure 14: Left: Sector lights in ECDIS, right: sector lights on the Greek paper nautical chart.

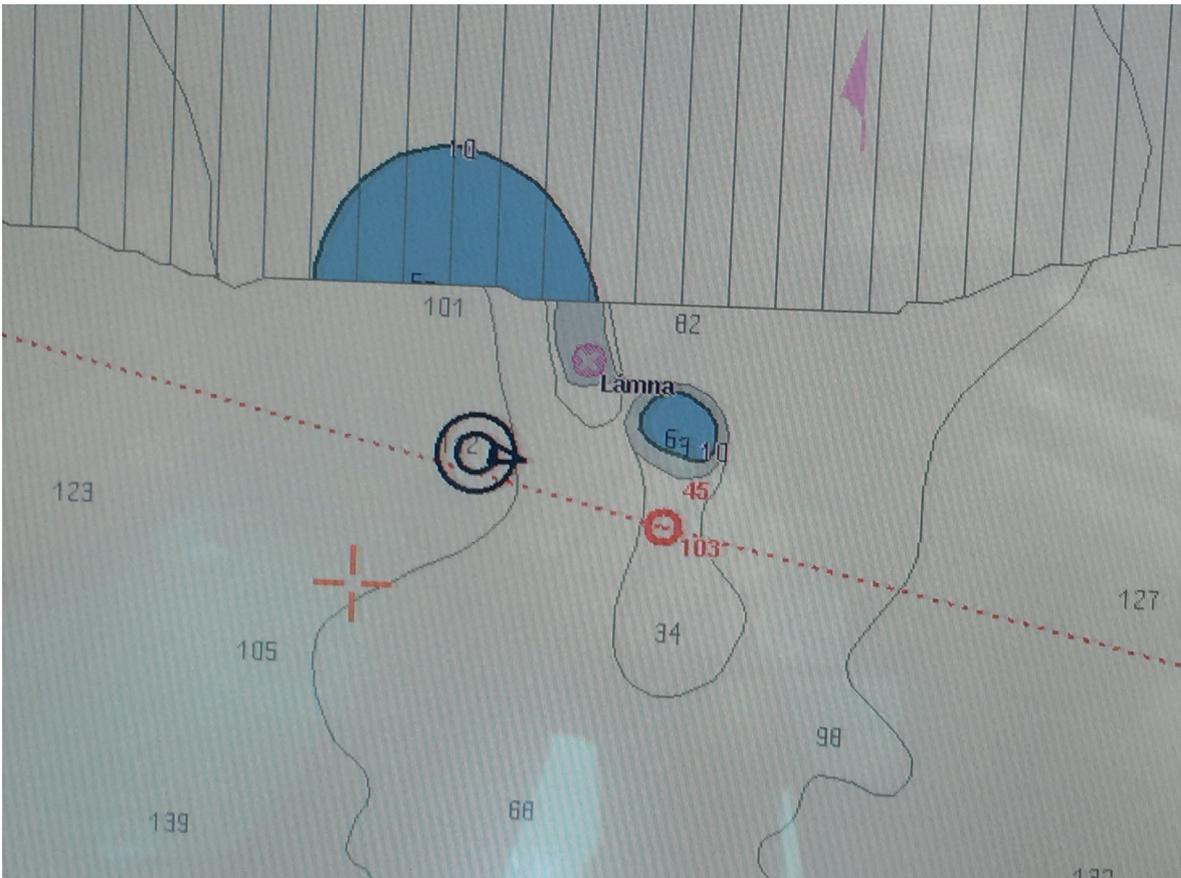
The possibility of zooming in on an ENC may create the feeling that highly accurate navigation is possible. In Figure 15, the Nova Cura appears to be at a reasonable distance from Lamnas Reef. Partly due to the high accuracy of GPS equipment, the ship's own position can be indicated very accurately. If, however, the ENC used to project this position is unreliable, positioning down to one metre does not count for much.

Figure 15: Zoomed in position of Nova Cura on ECDIS. Source: ECDIS Nova Cura

Apart from the fact that zooming in on an ENC may create the feeling that highly accurate navigation is possible, relevant information may also be omitted as a result of zooming in. If the officer of the watch does not regularly zoom out, he runs the risk of losing oversight.

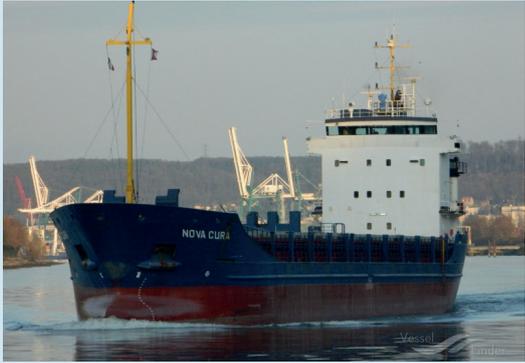
Vessel specifications	Nova Cura
Photo:

Call sign:	PCFP
IMO number:	9166479
Flag state:	The Netherlands
Home port:	Stavenisse
Vessel type:	General Cargo with Container Capacity
Classification society:	Bureau Veritas
Year of build:	1999
Shipyard:	Severnav Shipbuilding S.A. Turnu Severin
Length overall (LOA):	107,09 m.
Length between perpendiculars (LPP):	100,71 m.
Breadth:	15,0 m.
Actual draught:	6,41 m.
Gross Tonnage:	3999
Engines:	MAK 6M32
Propulsion:	1 propeller – controllable pitch, 1 bow thruster
Maximum propulsion power:	2919 kW
Maximum speed:	12.0 knots
Ship certificates:	All valid
